URBAN WATER MANAGEMENT IN KINGSTON, NY:
PLACING GREEN INFRASTRUCTURE IN TEMPORAL & SPATIAL CONTEXT

A Thesis

of Cornell University

December 2018

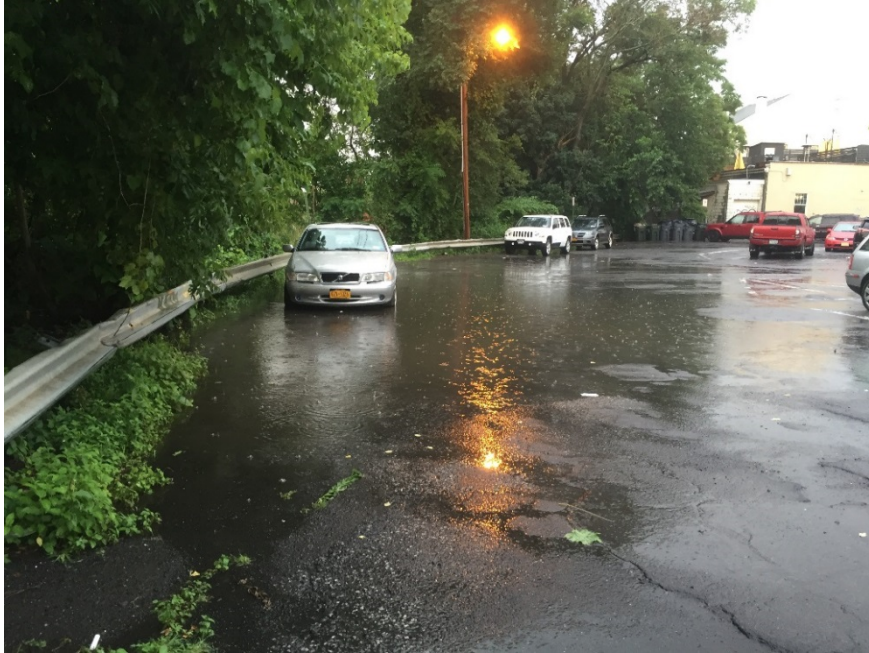
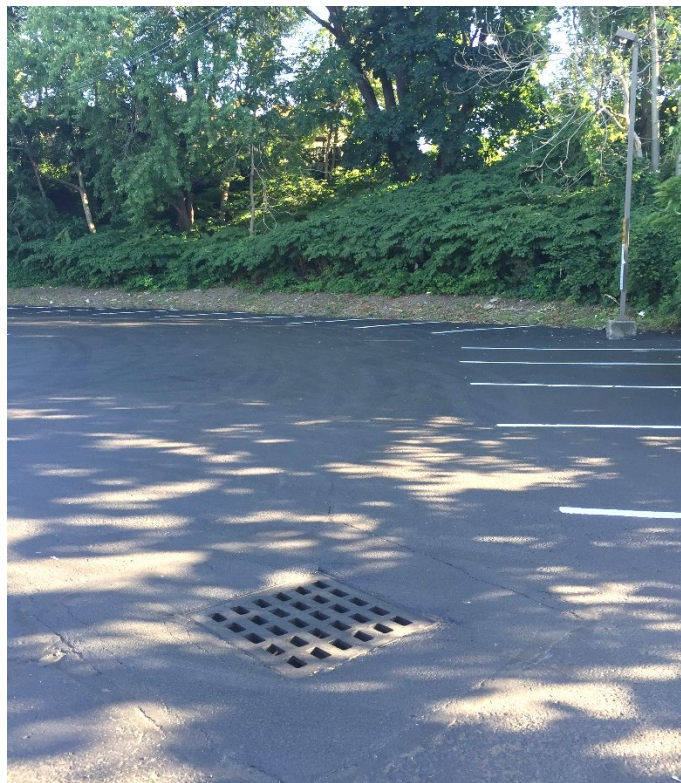
Figure 1.3: Pre-construction drainage in the North lot. As there were no storm drains or connections to the storm sewer system, runoff would flow to the north edge and run down the steep slope (top, from July 18, 2016). A storm drain in the parking lot below the slope (bottom, from August 8, 2016) likely collected runoff from the North lot.

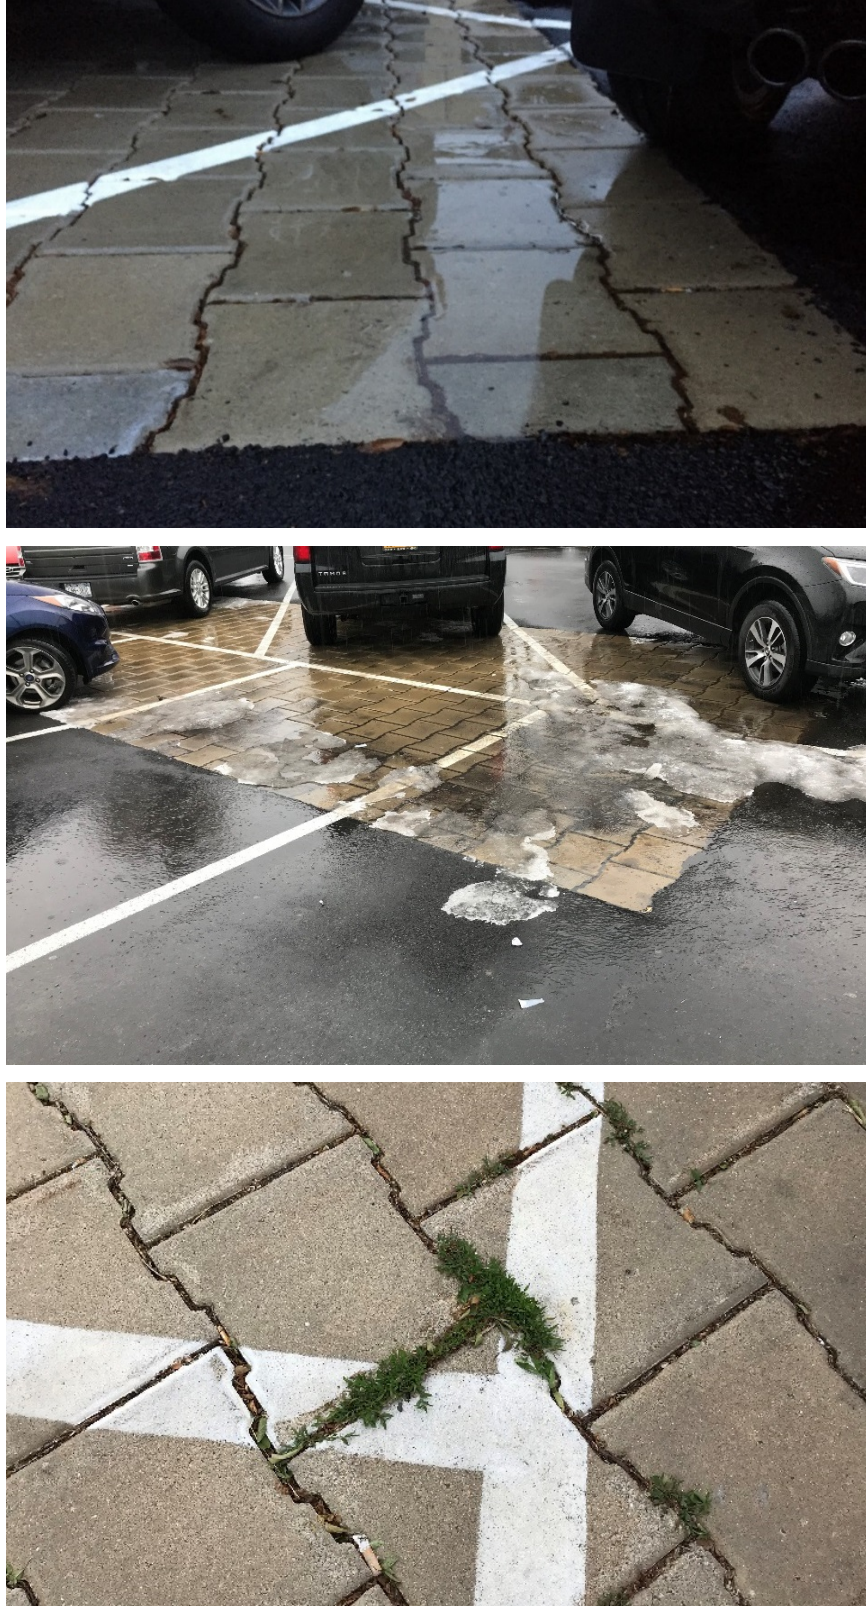
A section of pervious pavement on the west side of the North parking lot appeared to be clogged as early as November 30, 2016, about a month after construction (Figure 3.4). Water ponded above the pavers after heavy rain, and debris between the pavers seemed to be blocking the water’s flowpath. Litter and plant debris contributed to the clogging. This issue grew worse over time, and eventually enough sediment collected for weeds to grow between the pavers. This section of pervious pavers was not functioning properly, and would need to be vacuumed and maintained.

Figure 3.4: Clogging in pervious pavers in the North parking lot over time. (Top, November 30, 2016; middle, February 11, 2018; bottom, June 20, 2018.)

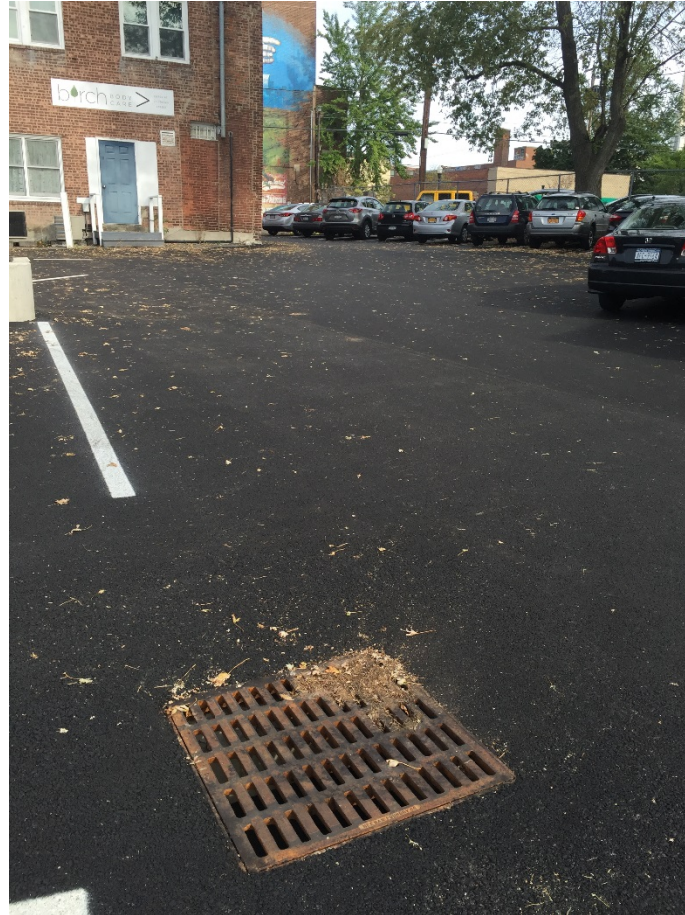
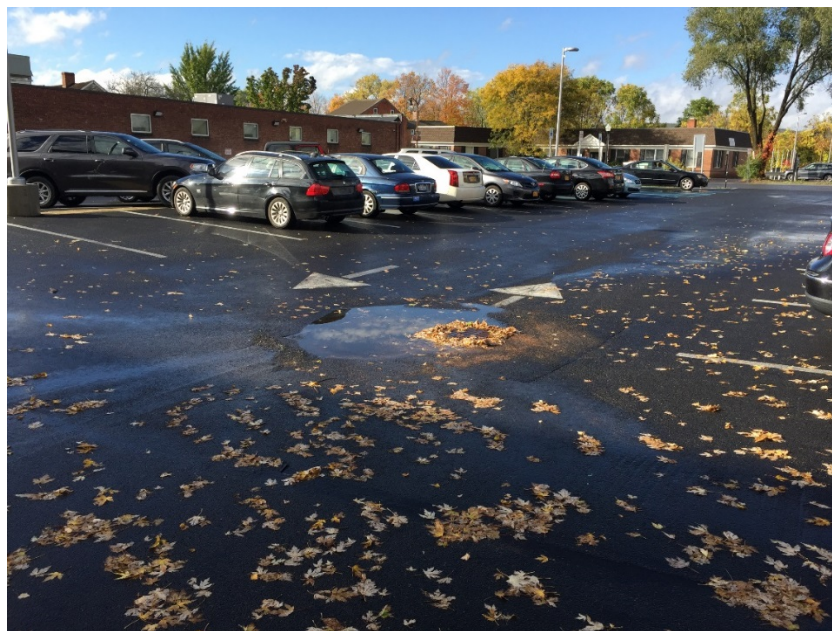
Figure 3.5: Leaf litter and debris collecting on the grate of Dry Well South 2. (Top, September 21, 2016; bottom, October 24, 2017.)

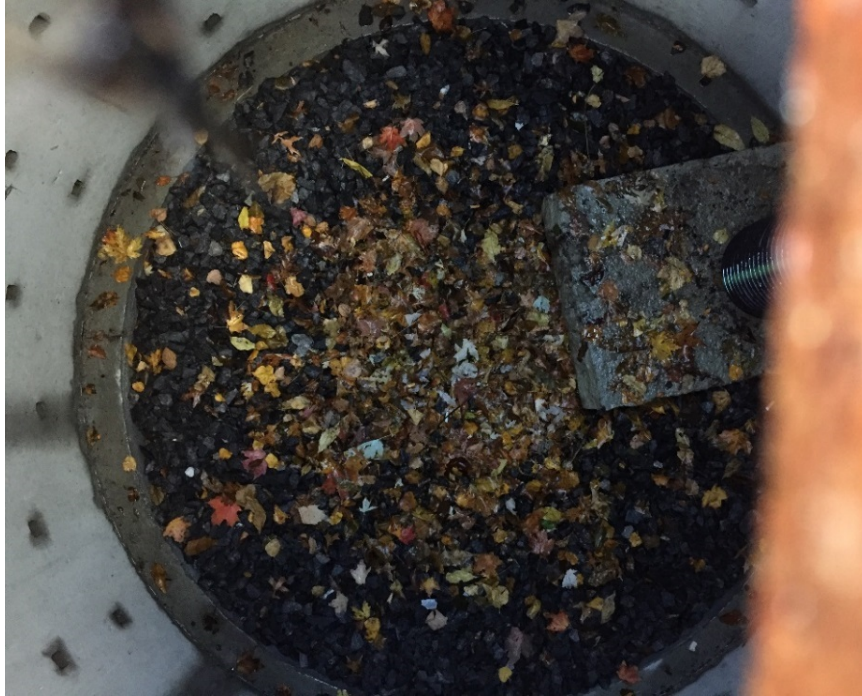
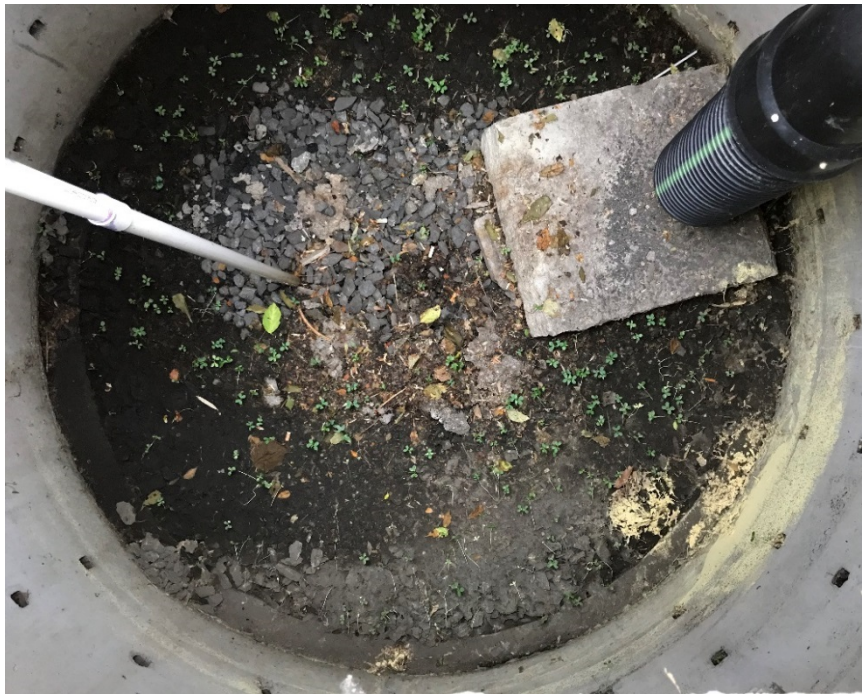
Figure 3.6: Debris at the bottom of Dry Well South 1. Leaf litter observed on October 28, 2016 (top) and plant growth observed on June 20, 2018 (bottom).

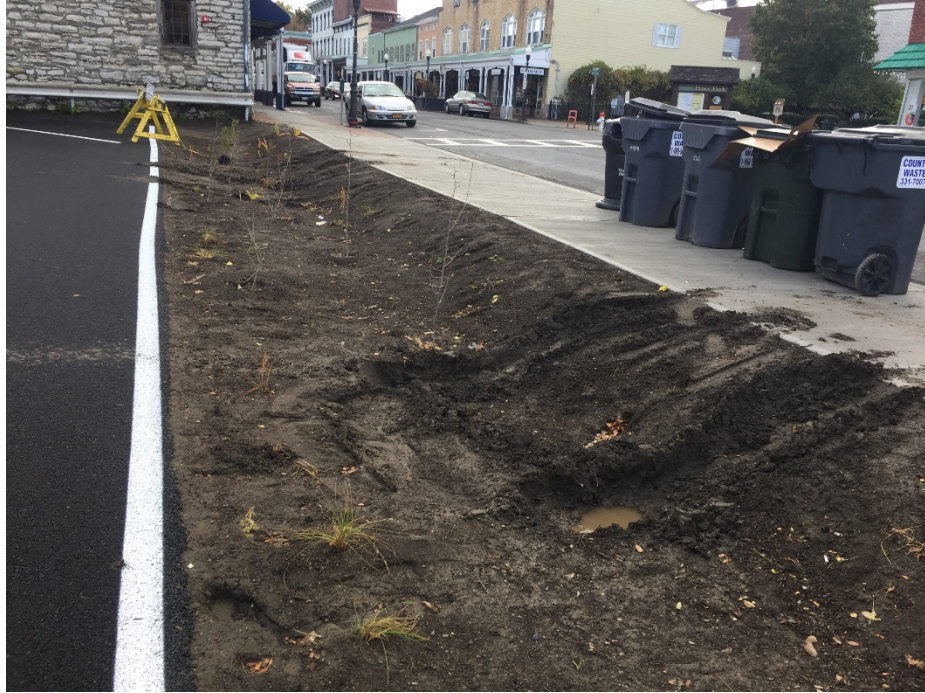
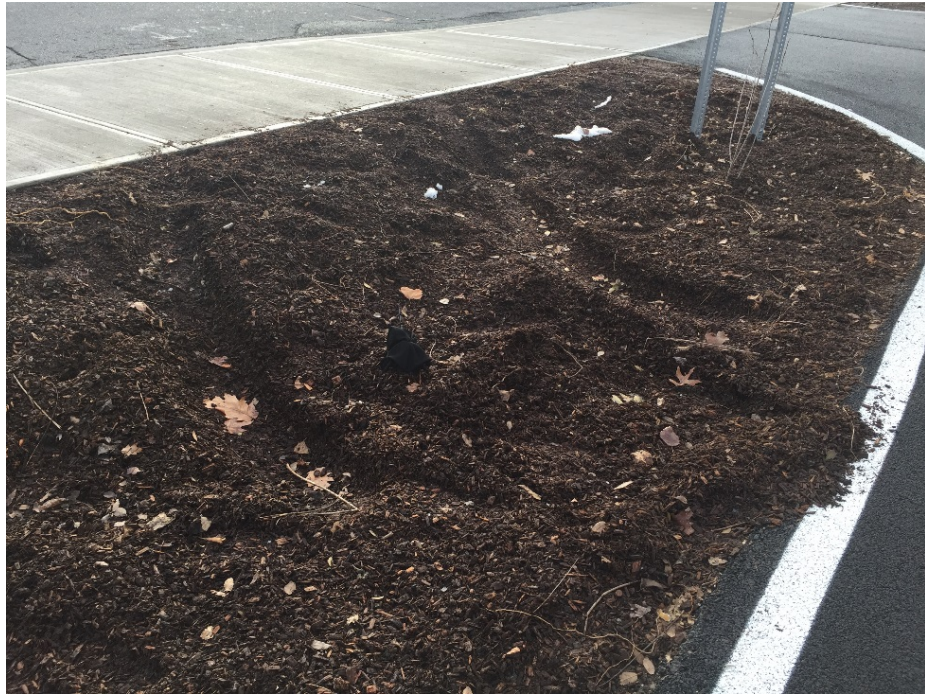
Figure 3.7: Multiple sets of tire tracks, indicating people driving through Bioretention Area North on October 28, 2016 (top) and December 7, 2016 (bottom).

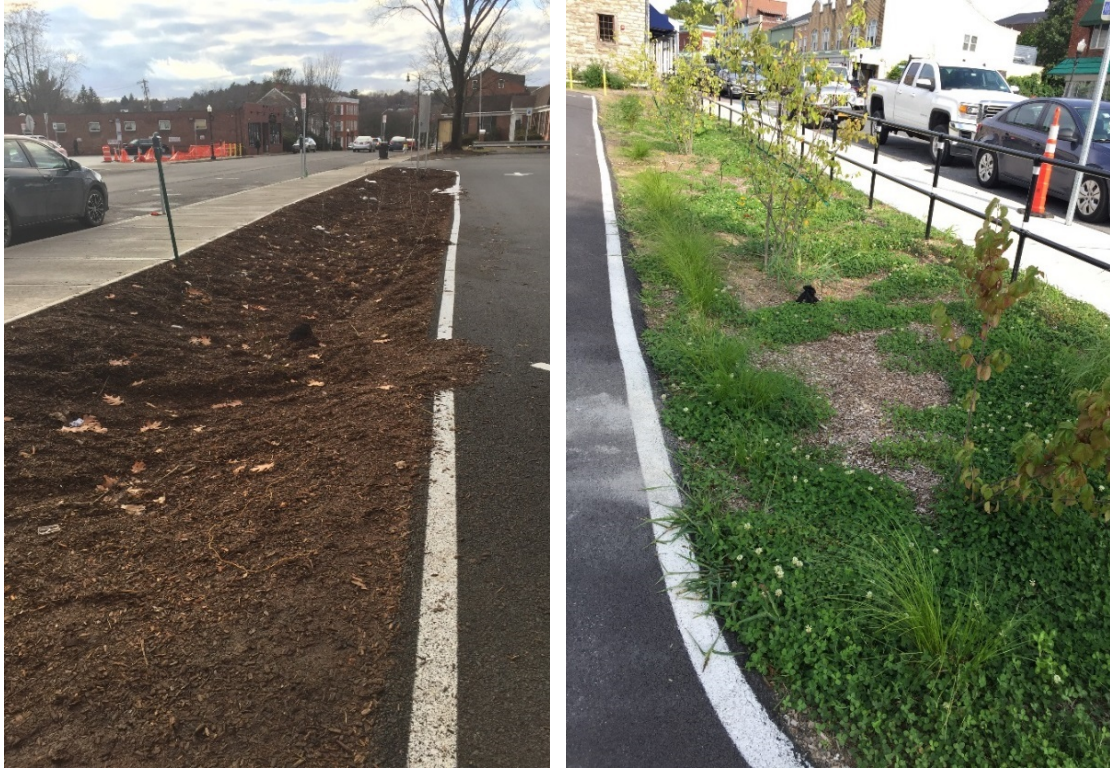
Figure 3.21: Mulch in Bioretention Area North when it was first added (left, December 7, 2016), and with some weed growth during the first summer (right, August 17, 2017).

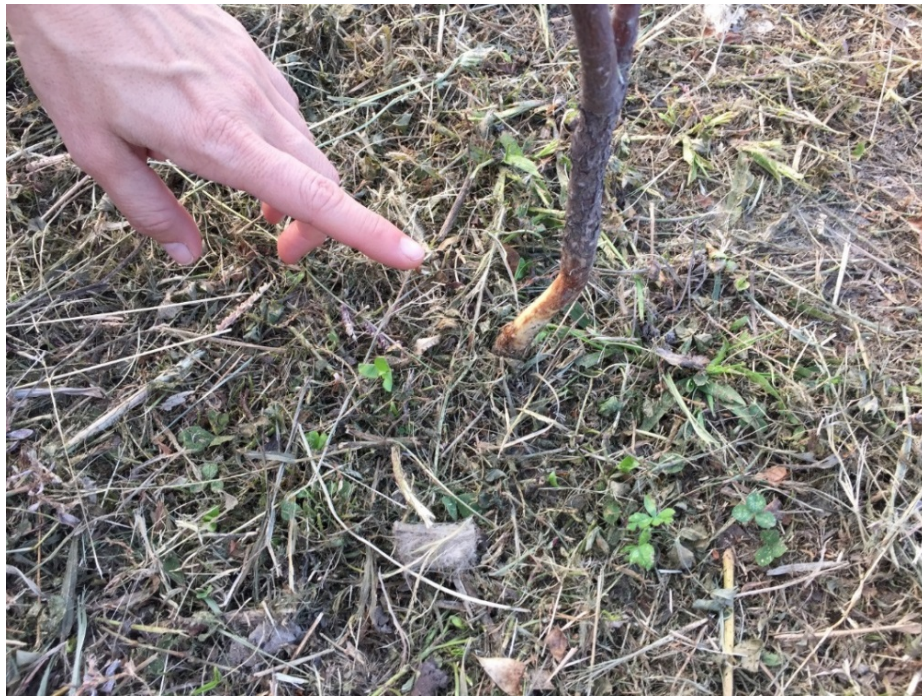
Figure 3.22: Damage from mowing to serviceberry shrub in bioretention area (September 13, 2017).

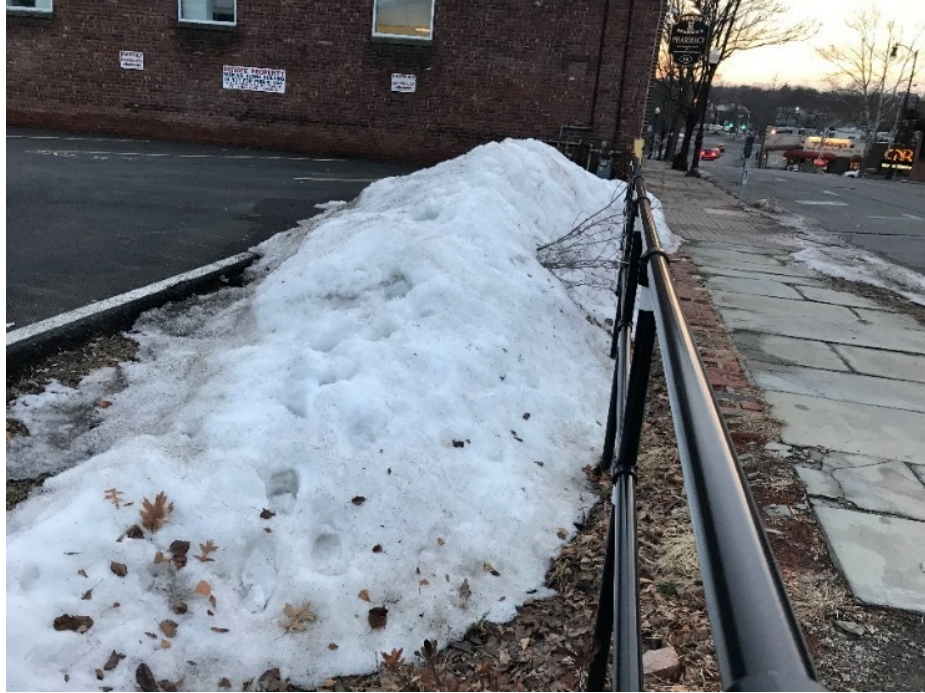
Figure 3.23: Vegetation damage from winter plowing in Bioretention Area South 2 (January 29, 2018).

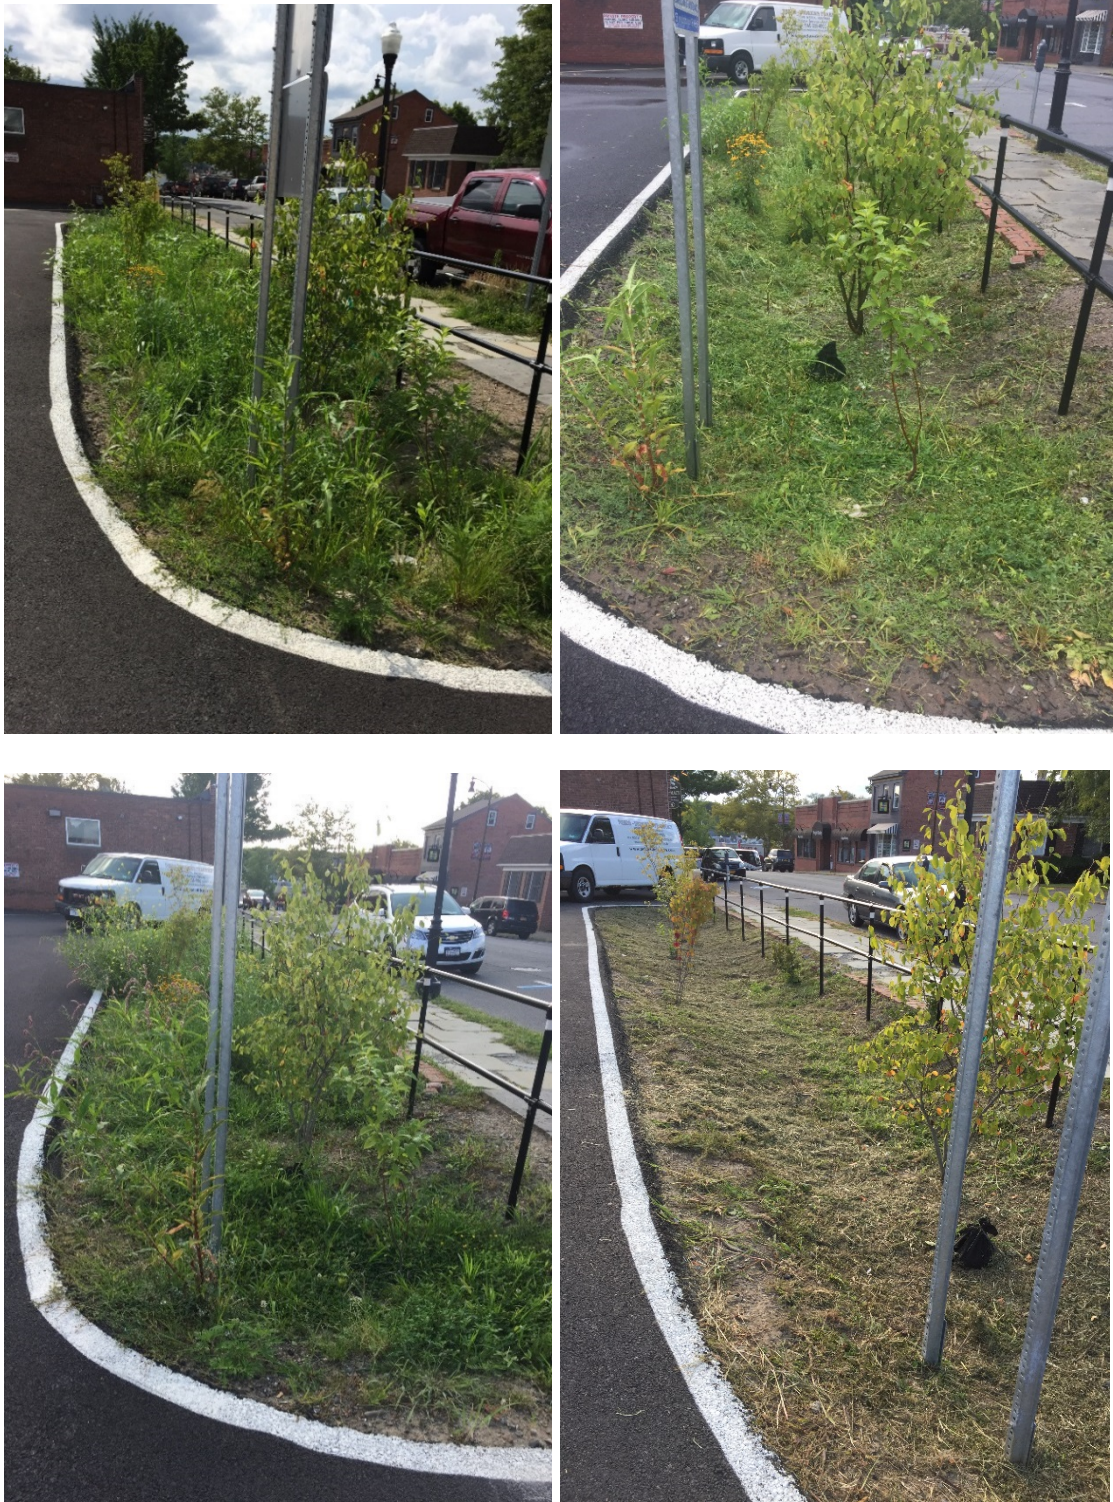
Figure 3.25: Progression of mowing and maintenance on vegetation in Bioretention Area South 2. Photos are from July 28, 2017 (top left), August 4, 2017 (top right), August 24, 2017 (bottom left), and September 13, 2017 (bottom right).

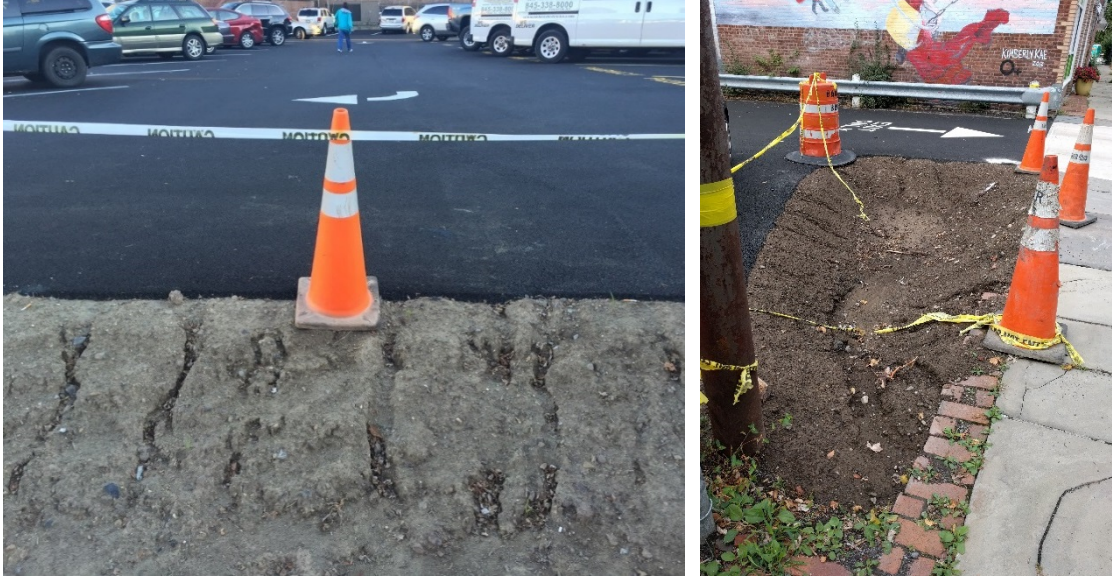
Figure 3.26: Rills initially formed after construction and before planting along the edge of Bioretention Area South 2 (left, October 5, 2016) and Rain Garden South (right, September 12, 2016, photo by Beth Roessler).

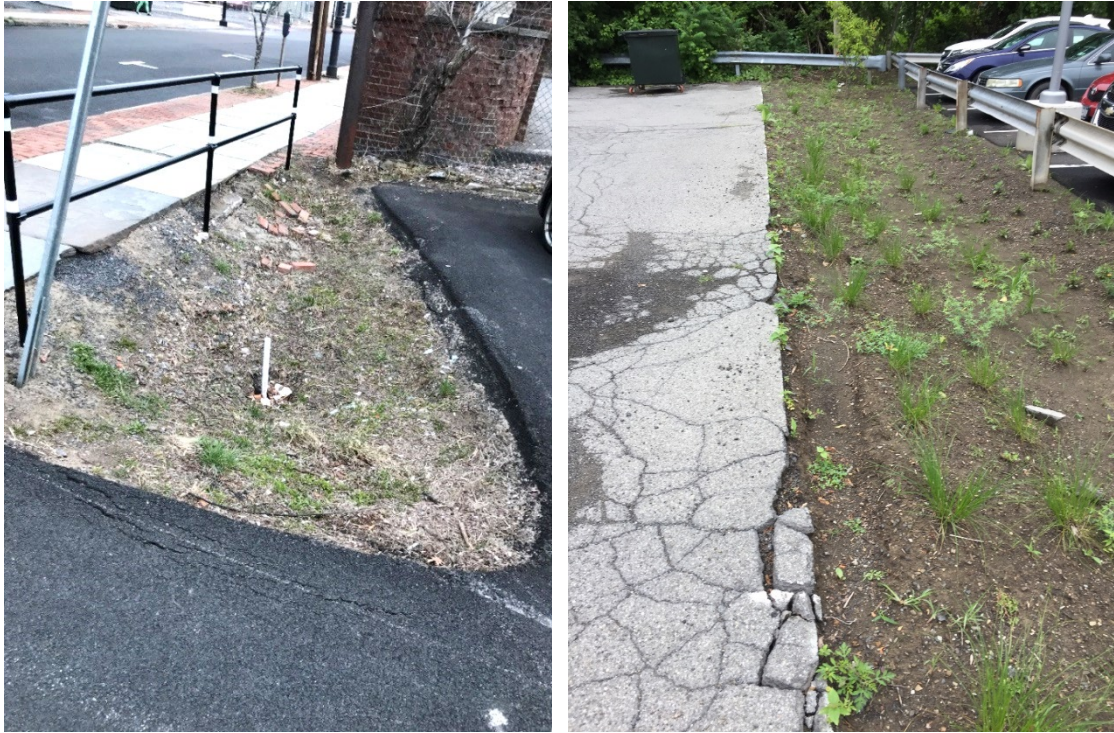
Figure 3.29: Asphalt cracking along Rain Garden South (left, April 9, 2018) and Rain Garden North (right) on the side opposite of the parking lot. Cracking worsened around Rain Garden South over time, and could cause structural damage.

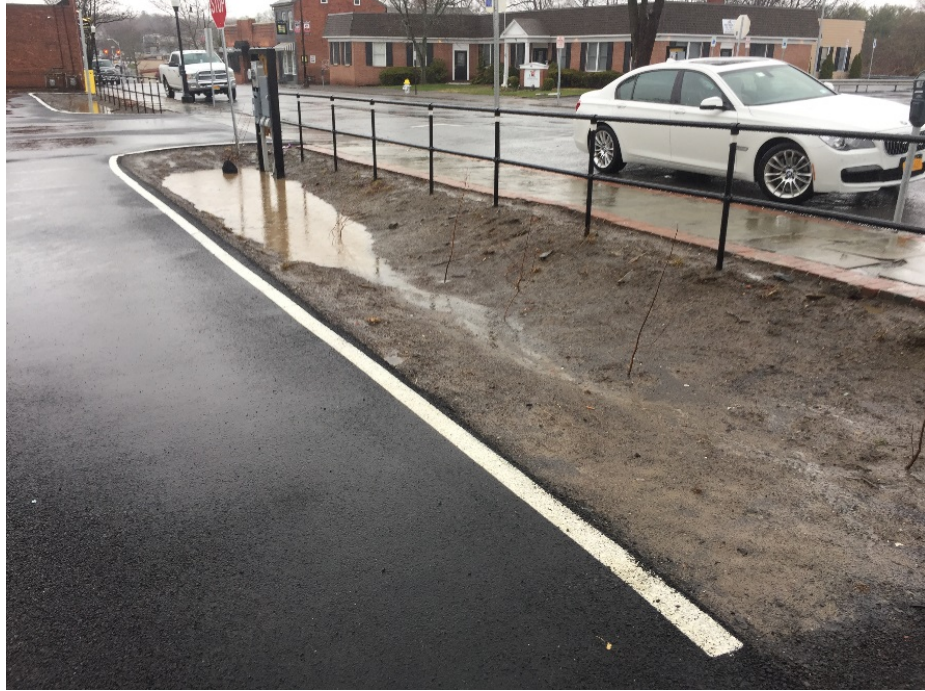
Figure 3.31: Deeper ponding on one side of Bioretention South 1, indicating that the bottom surface is not flat (April 6, 2017).

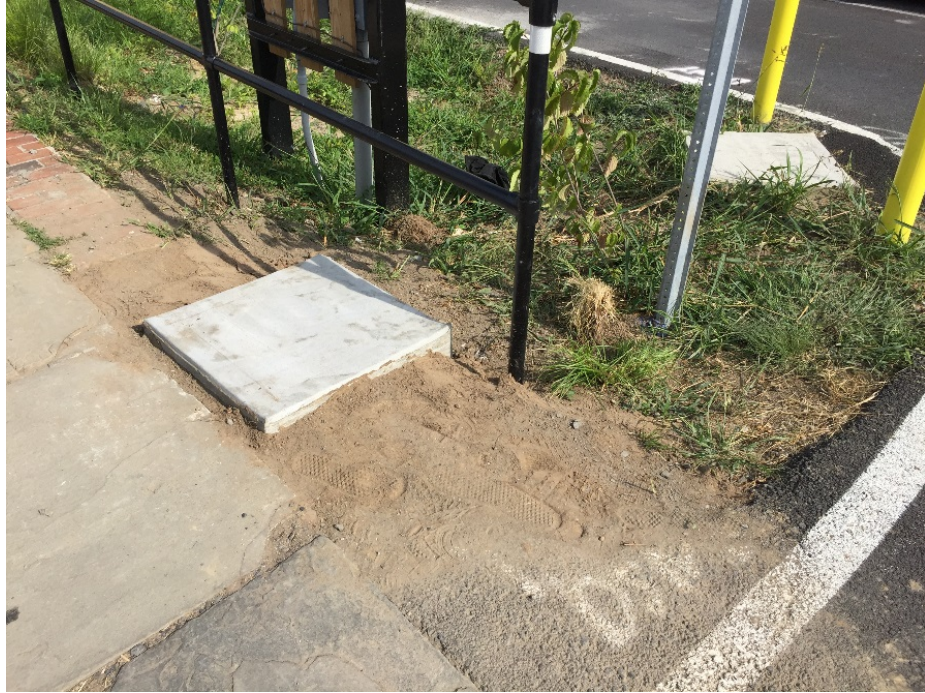
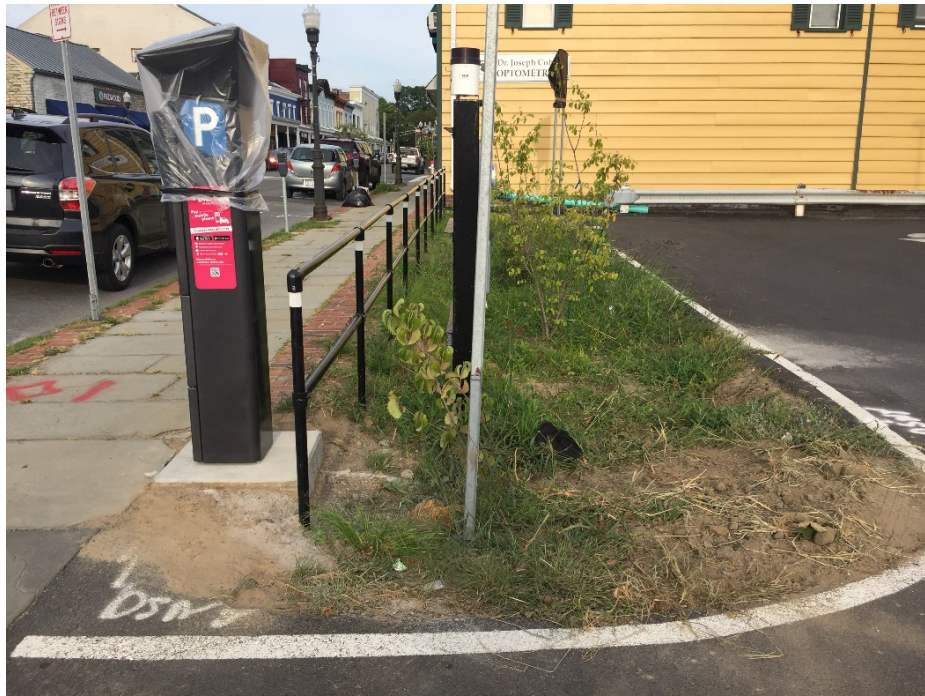
Figure 3.34: Concrete blocks placed within Bioretention Area South 1 for a new parking meter. The original location for the meter was moved (top, August 17, 2017) to a location along the sidewalk (bottom, August 28, 2017), leaving a disturbed area with bare soil in the bioretention area.

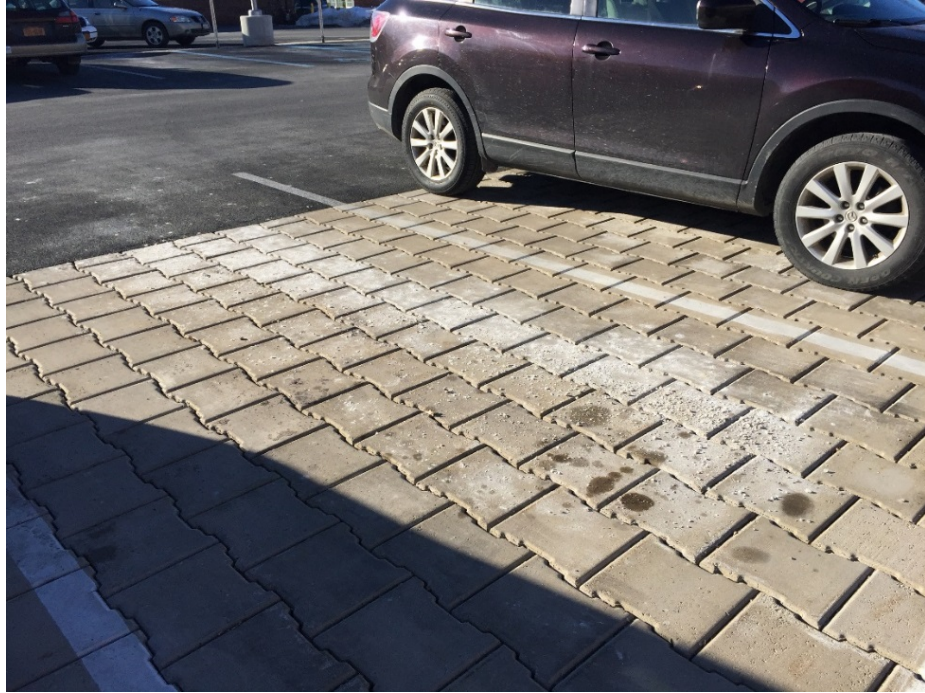
Figure 3.36: Rock salt on pervious pavers in the South parking lot (February 22, 2017).

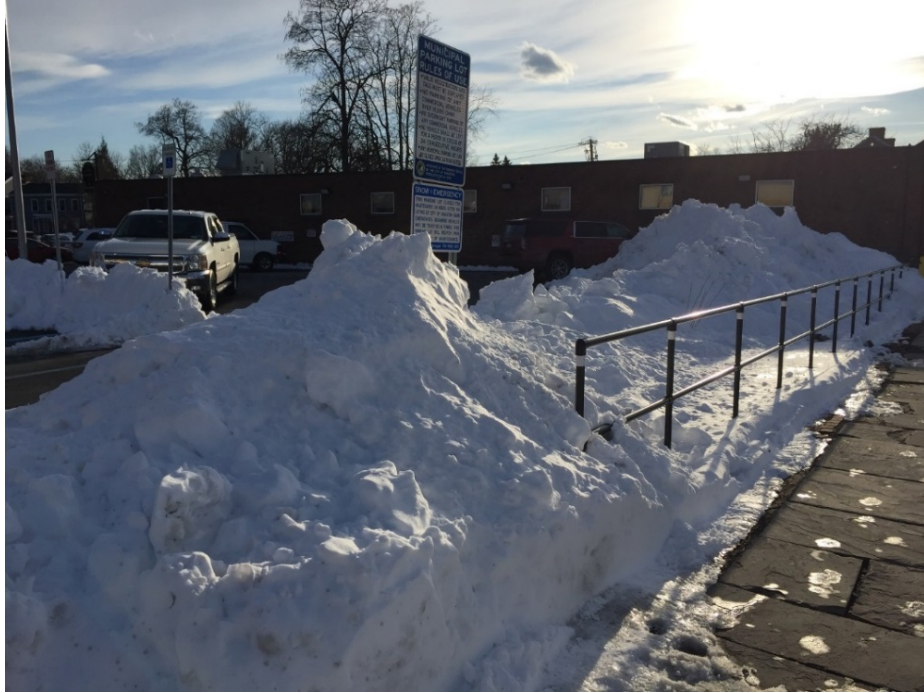
Figure 3.37: Snow piled up in Bioretention South 2 (March 16, 2017).

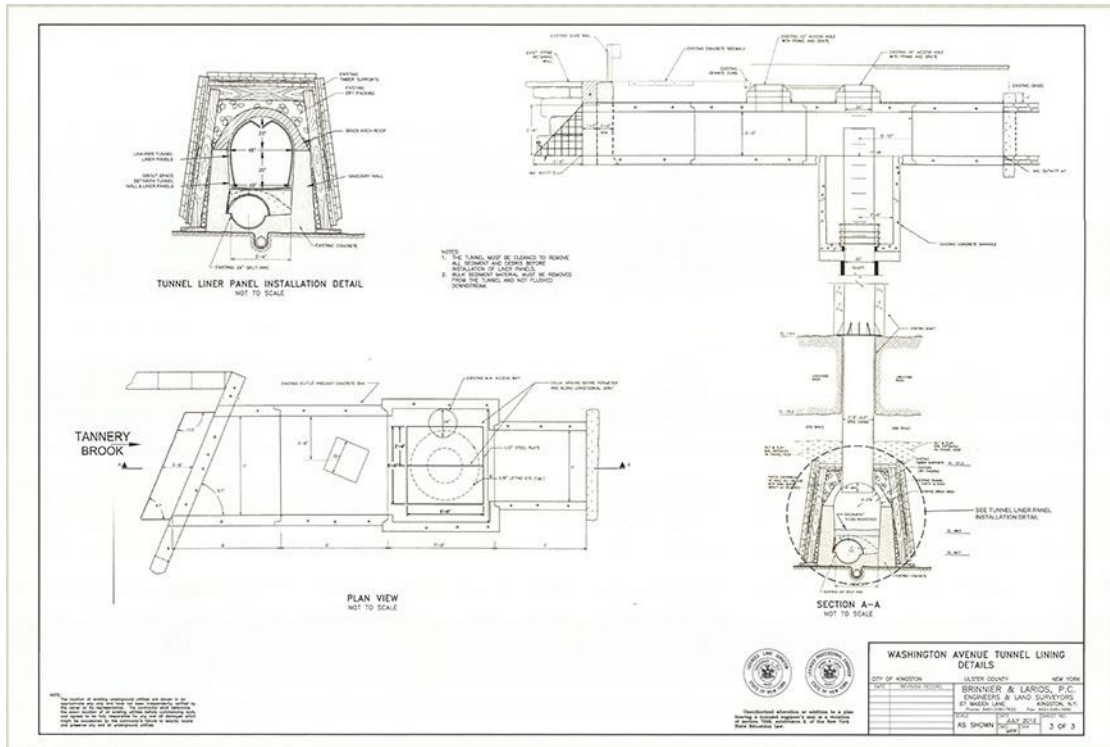
“Washington Avenue Tunnel Lining Details.” 2012. Brinnier & Larios. Ulster County Department of the Environment. This drawing displays how the void space around the Tannery Brook shaft caused the road to collapse.
